The following modifications now apply to standard 6-cylinder engines starting October 1971:

Standard Installation of Modified Versions a - e

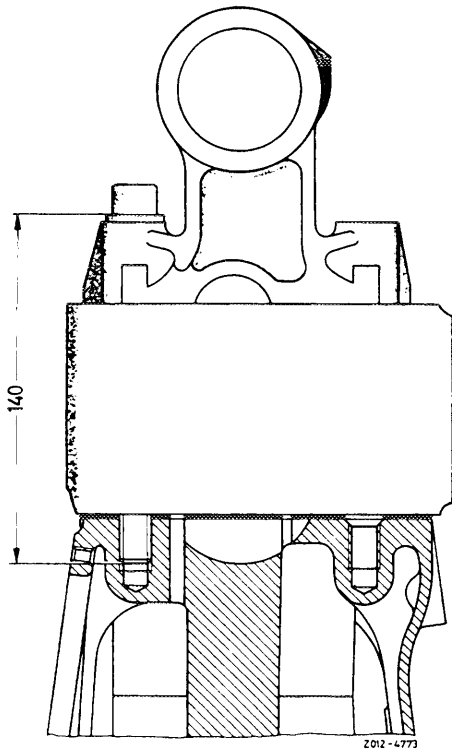
Fig. 01-11/1

Former version

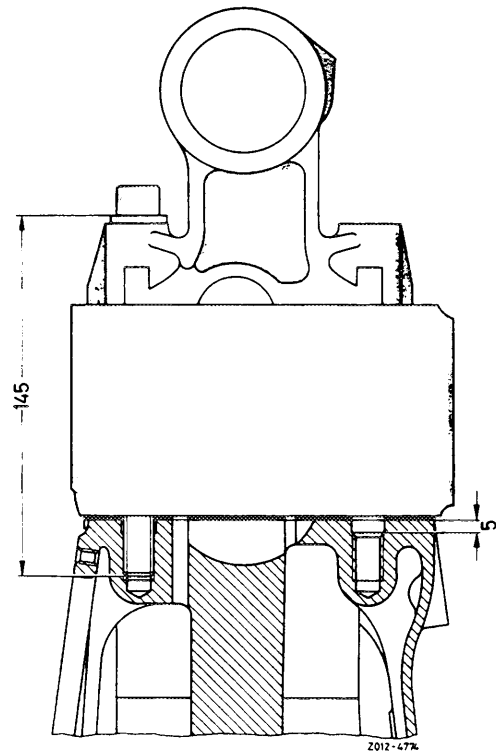
Fig. 01-11/2

These tapped holes are countersunk for 5 mm at cylinder crankcase and are drilled that much deeper. Therefore, cylinder head bolts are now 115 and 145 mm long (formerly 110 and 140 mm) (Fig. 01-11/2).

Modified version

Caution! Cylinder head bolts M 12 x 140 and M 12 x 110 may no longer be used for the modified cylinder crankcase, because threads may be torn out. Vice versa, cylinder head bolts M 12 x 145 and M 12 x 115 may not be screwed into cylinder crankcase of version used up to now, because they will be stuck at bottom of hole.

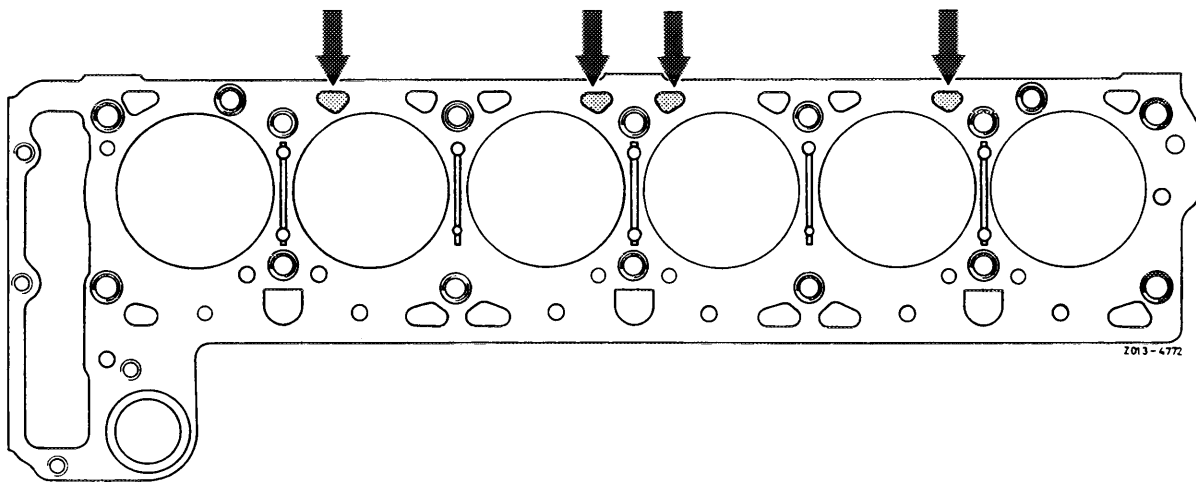
Fig. 01-11/3

The cylinder crankcase has been provided with four additional kidney-shaped cooling water holes (Fig. 01-11/3).

Parting surface cylinder crankcase

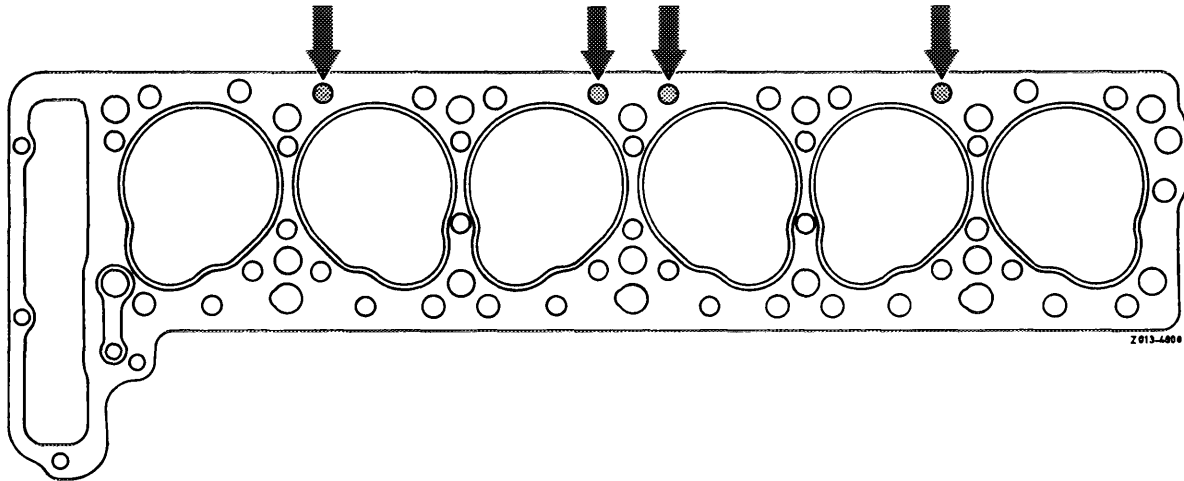
Fig. 01-11/4

In accordance with these cooling water holes, a modified cylinder head gasket with four additional

round holes will be used (Fig. 01-11/4).

Modified cylinder head gasket.

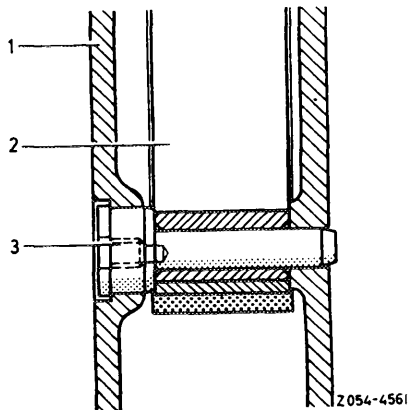
Fig. 01-11/5

These vehicles were provided with the slide rail bearing bolt which is already used as a tensioning rail bearing bolt on four-cylinder models.

Caution! Be sure to coat sealing surfaces of bearing bolts with Hylomar sealing compound during installation. For pulling-out bearing bolt, use impact puller 116 589 20 33 00 (basic unit) and threaded

bolts M 6, 116 589 02 34 00, or threaded bolts M 8, 116 589 03 34 00.

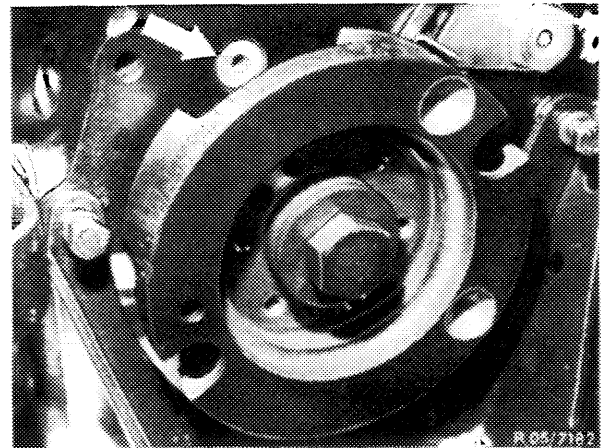
Fig. 01-11/6

Arrow: Bearing bolt

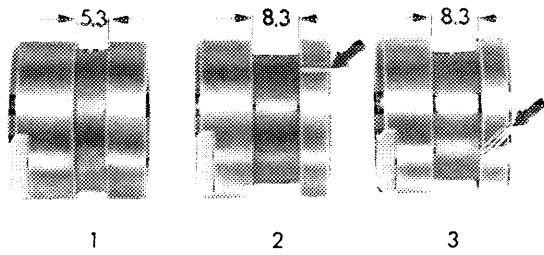
Fig. 01-11/7

The oil groove at front bearing bushing of intermediate gear shaft has been increased and a notch has been applied (arrow in Fig. 01-11/7).

Arrow: Additional notch

Caution! This bearing bushing can be installed in modified crankcase only.

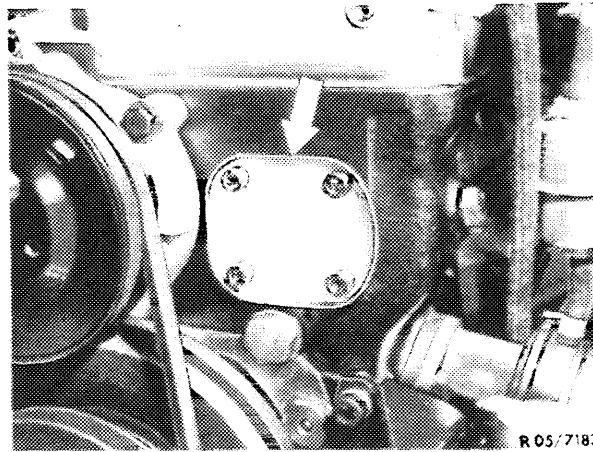
Fig. 01-11/8

Fastening bolts and tapped holes in cylinder crankcase were changed from M 6 x 12 to M 8 x 12 (Fig. 01-11/8).

Arrow: Closing cover

Accordingly, the closing cover on cylinder crankcase and the pertinent gasket were also changed.

Caution! The modified closing cover and the pertinent gasket may be used only on engines with tapped holes M 8. On engines with tapped holes M 6, use former closing cover with pertinent gasket. Both parts will continue to be available as a spare part.
