Models 200/8, 220/8 and 250/8

The rocker arm bearing on engines for Models 200/8, 220/8 and 250/8 have been modified. The new version comprises the threaded bolt 130 055 01 74 and the ball pin 130 055 01 21. This modification results in a few facts which must be observed when walking on rocker arm bearings.

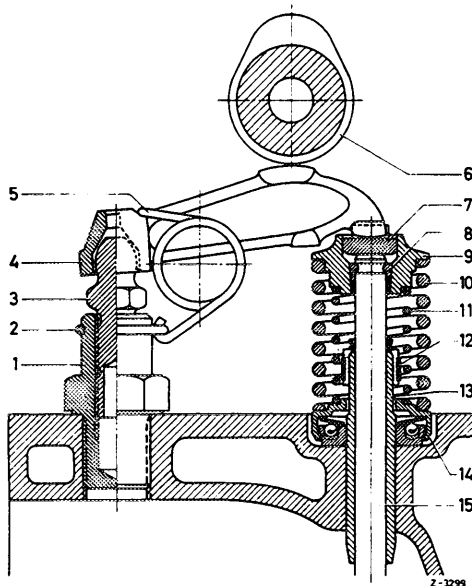
Fig. 05-4/1

- 1 Threaded bolt
- 3 Ball pin
- 7 Thrust piece

There is also a possibility that the ball pin will become seated in threaded bolt, so that the specified valve clearance cannot be adjusted (Fig. 05-4/5). This border case can be repaired by exchanging the thrust piece (Item 7, Fig. 05-4/1). Production

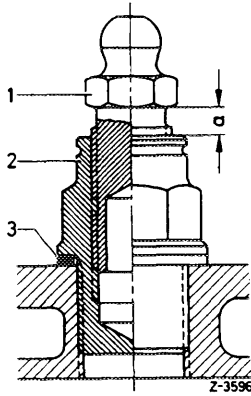
Fig. 05-4/4

If the specified torque is not attained even when using a new threaded bolt because the ball pin must be screwed out too far, add a washer (self-made 2 mm thick at base of threaded bolt (Item 3, Fig. 05-4/4).
