05–225 Grinding camshaft journals

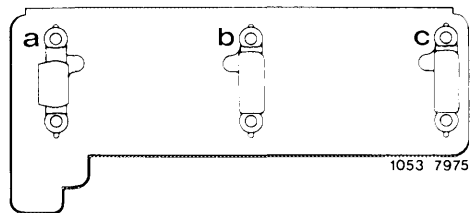
Engines 615, 616

End face a will have to be reground if dimension A is exceeded by grinding No. 1 journal.

Peak-to-valley height of camshaft journals		0.003			
Permissible eccentricity of center bearings and of camshaft sprocket seat, with camshaft mounted at outer bearings	Camshaft code ¹⁾	02	06.10	00	08
	Camshaft sprocket seat	0.012	0.025	0.020	0.020
	2nd bearing (b)	0.012	0.025	0.030	0.030
	3rd bearing (c)	—	—	0.025	0.025
Bearings (illustration)		a	b, c and d		
Normal size	Camshaft bearing dia.	<u>35.00</u> 35.02	<u>46.50</u> 46.52	<u>49.00</u> 49.02	²⁾
	Journal dia.	<u>34.95</u> 34.93	<u>46.45</u> 46.43	<u>48.95</u> 48.93	²⁾
Intermediate stage	Camshaft bearing dia. (grey color code)	<u>34.90</u> 34.92	<u>46.40</u> 46.42	<u>48.90</u> 48.92	²⁾
	Journal dia.	<u>34.85</u> 34.83	<u>46.35</u> 46.33	<u>48.85</u> 48.83	²⁾
Repair stage	Camshaft bearing dia. (red color code)	<u>34.75</u> 34.77	<u>46.25</u> 46.27	<u>48.75</u> 48.77	²⁾
	Journal dia.	<u>34.70</u> 34.68	<u>46.20</u> 46.18	<u>48.70</u> 48.68	²⁾
Width A of journal a (illustration)		<u>34.00</u> 34.04	—

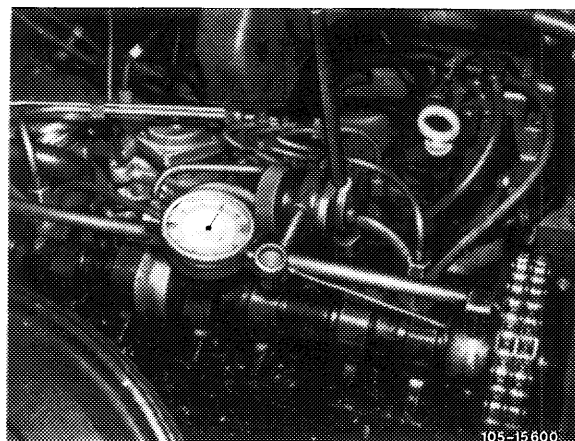
Measuring end play

- 1 Using threaded sleeve, attach dial gauge holder at front left.
- 2 Preload dial gauge by about 3 mm on thrust collar of camshaft.
- 3 Force camshaft aft and set large pointer to zero.

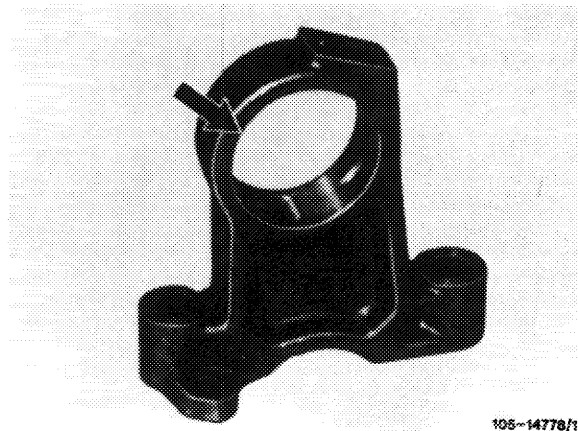
4 Force camshaft forward and measure end play.

Note: Faces of No. 1 camshaft bearing (arrow) will have to be dressed if end play is inadequate.

End face a of No. 1 camshaft journal will need regrinding if end play is excessive.
